**BOOM ARM MOWER**

# **INFORMATION & SERVICE BULLETINS**

Manual P/N 02980501  
(08/05)

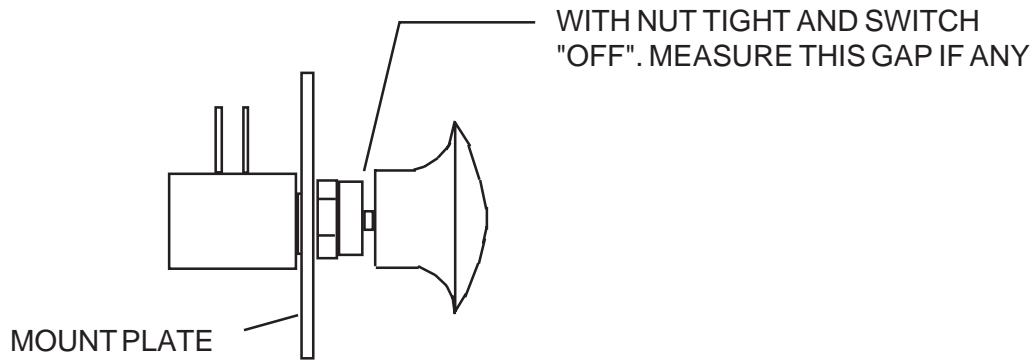
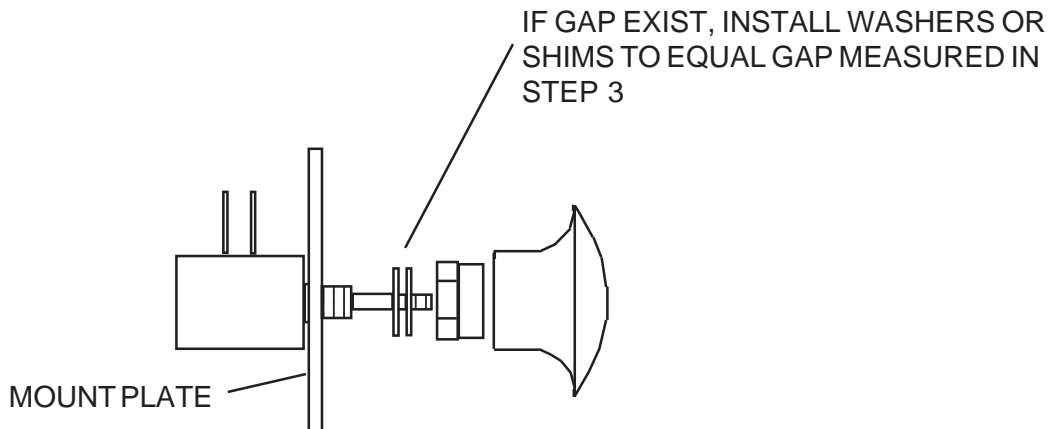
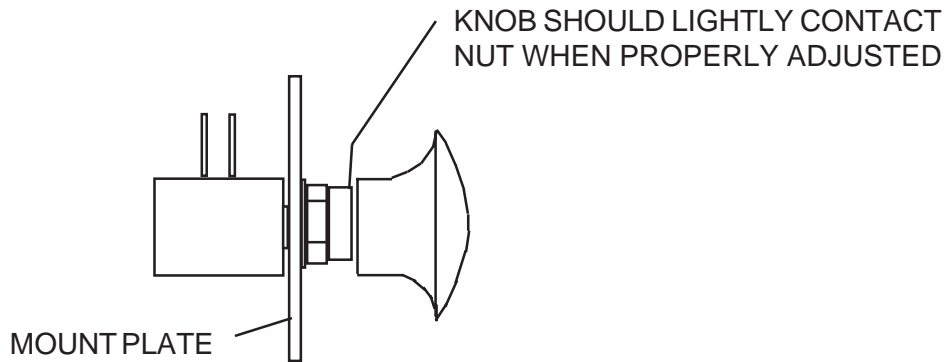
### **Failures of the mower push-pull switch:**

Alamo has recently received reports of failures of the referenced switch. The failures modes are:

Test performed on numerous switches indicates that the (b) failures are due to excessive force being applied to the knob when shutting off the mower. Specifically, the knobs are usually roughly slapped to turn the mower off. After internal parts of the switch are damaged, the rod can then be pulled out easily. The (a) failures are due to the knobs not being securely tightened.

To prevent these failures from occurring, or to replace a damaged switch, use the following procedure to adjust the travel of the switch. (See attached diagram).

6. Install the Knob, using Loctite or similar thread locking compound. Thread the knob on the rod all the way. Test to make sure that when the switch is "Off" (with rod pushed in) that the knob can not travel further into the switch.

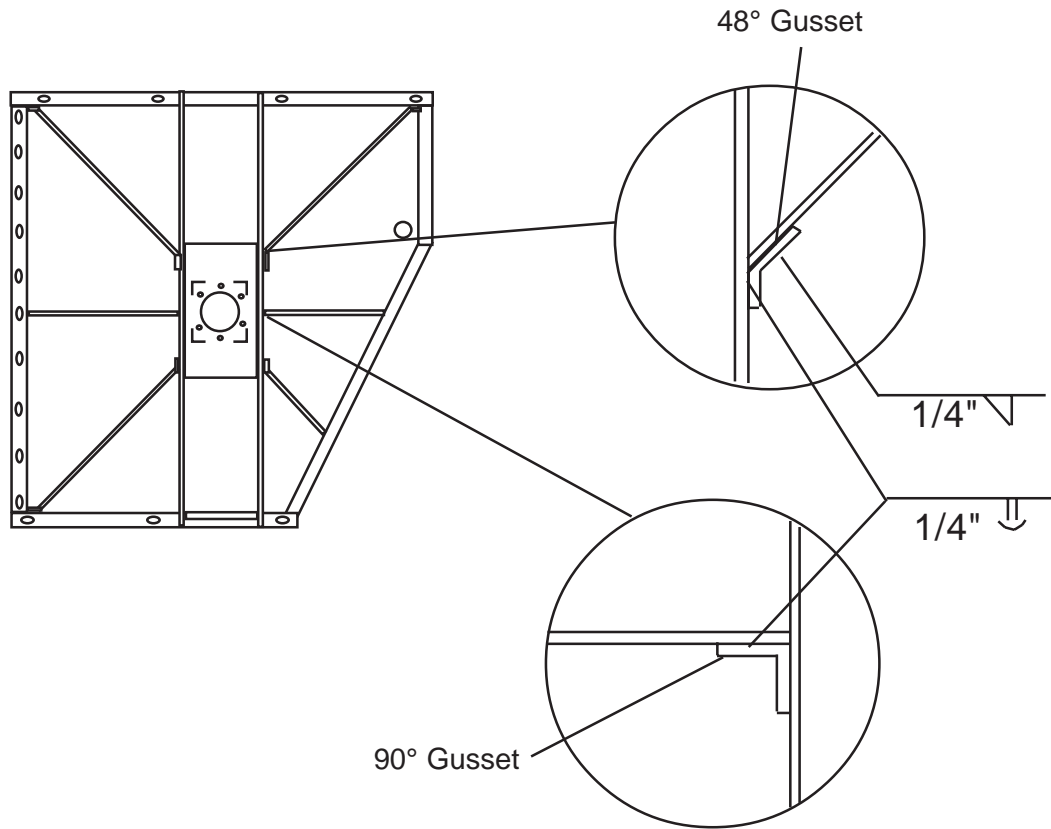
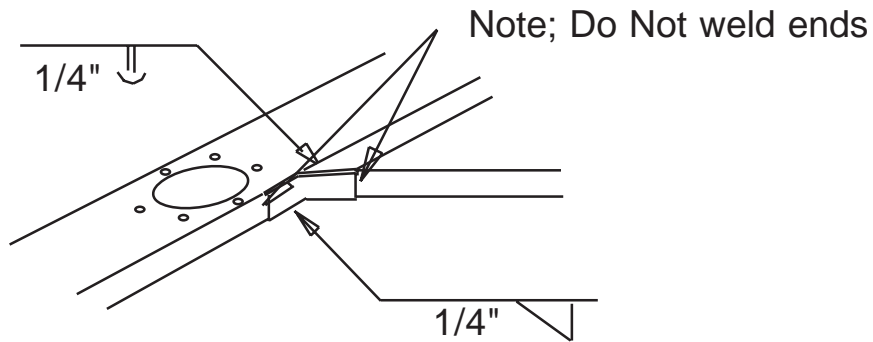
### Repair Procedure for Welding Cracks in Boom Heads:

If cracks appear in the welds at points "A" as shown above, use the following procedures to repair head.

1. Grind a groove at the site of the crack and clean the area to be welded.
2. Weld the crack making a 100% weld.
3. After repairing the cracks, prepare the sites for installation of the gussets.
4. Position the reinforcing bar gusset part no. 02970111 if 90° or part no. 02970112 if 48° over the X-Bar as shown in drawing next page. Weld with a 1/4" fillet weld on the bottom and an edge weld on top. DO NOT weld the ends.
5. Clean and paint the area.
6. Reassemble any parts that were removed.

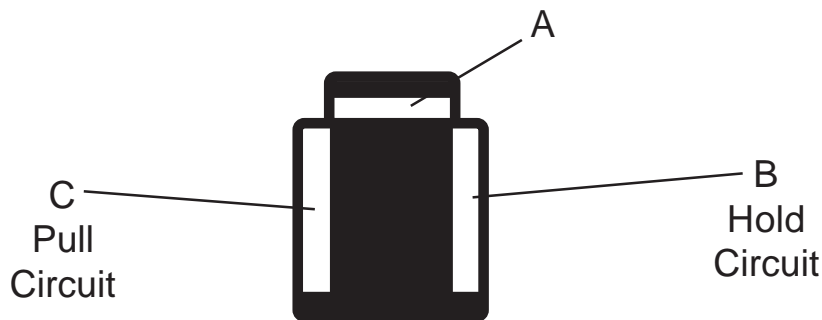
If the harness is wired wrong, the motor will start as soon as the Motor Start Switch is pulled out without pressing the Motor Start Button.

The above illustration is the female connector of the motor wire harness

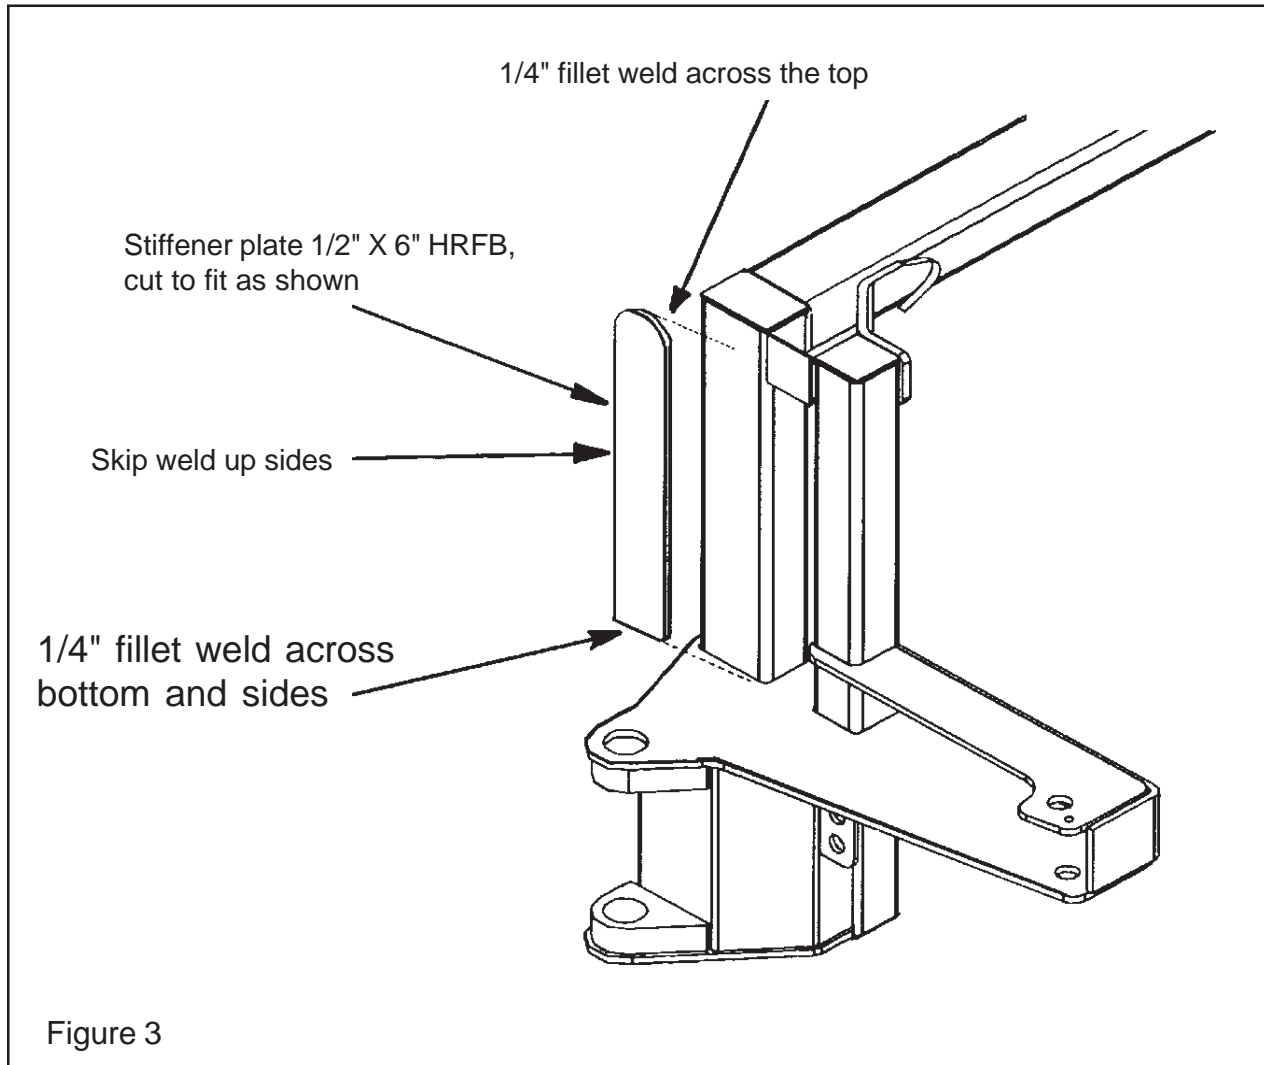
## Cracks in Main Frame:

1. Grind out old weld (crack) and weld the crack, Do not use an excessive high repair weld as you will need to grind repair weld down smooth.
2. Prepare a piece of 1/2" X 6" HRFB cut to length (See Figure 2). The bottom should rest against the King Post frame and the top should be within 2" of the top of the frame, this will determine the height of the repair plate (See Figure 3). Bevel the bottom side of the plate that is towards the frame to allow for the old weld. This will be evident if you test fit the repair plate.
3. Place the stiffener repair plate against the vertical member of frame (as shown in figure 3) and tack weld into position, Make sure repair plate is flat against the frame.

4. Weld the plate as described in figure 3
5. After welding is complete, clean weld and immediate area. Paint the area around the repair and around any area where the paint was damaged from making this repair.

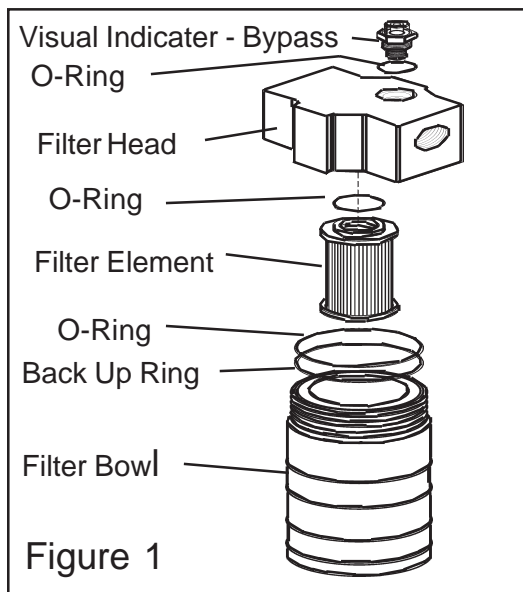
Detailed investigation of recent valve failures revealed that in the vast majority of the incidences, the failures are attributable to contamination within the tractor hydraulic systems which supply pressure to the control valve. Failure normally take the form of one or more inoperative or poorly operating functions. Repair may involve the replacement of the electronic controller for the section or, in severe cases, the replacement of the entire valve. Particulate contamination in the form of small gear metal or brass particles created during break-in and operation and are not removed during required maintenance of the tractor can enter the valve, this creates leakage due to wear or clogging of passageways.

Installation of the Filter Kit will greatly reduce the possibility of the occurrence of failures within the Machete control valve due to particulate contamination. This contamination may result from poor maintenance of the tractor hydraulic system or other hydraulic system performance characteristics or problems.

An indicator located on the top of the filter housing will indicate when the filter is bypassing thus requiring the replacement of the filter element. The element is a canister insert which is easily replaced by unscrewing the cannister.

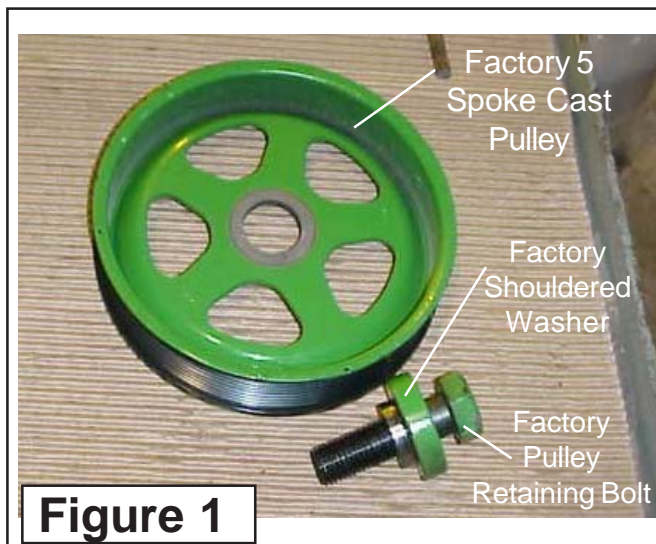
**Figure 1**

In an effort to comply with certain requirements in regard to Tier II Emission Standards, Deere and Company initiated a change to the crank shaft pulley on many of the new 6020 series tractors. This was a random change, which did not affect all tractors. In addition, a specific serial number break does not exist to identify the affected units.

The Tier II pulley can be identified as a 5 spoke design as indicated in the figure above (See Figure 1). This pulley must be changed to the tapered lock, solid cast pulley as shown to allow adaptation of the required front pump drive system used to power the Alamo Industrial products. (See Figure 2)

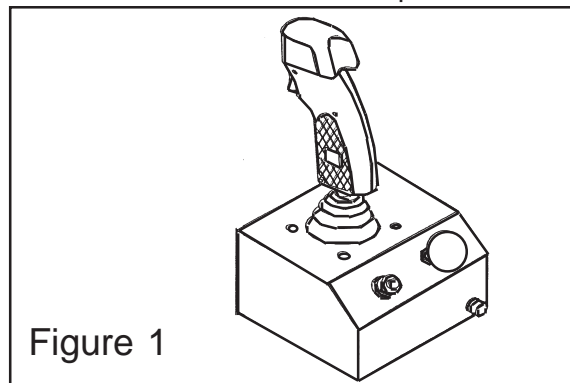
Figure 1

See Operators manual or Service Manual for Wire Harness connections.

- Install the replacement control box (Joystick) in the reverse order and test operate unit.

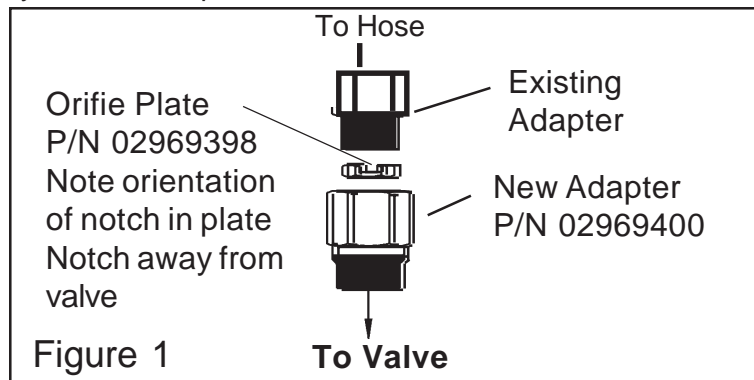
See Operators manual or Service Manual for Port locations on valve if needed.

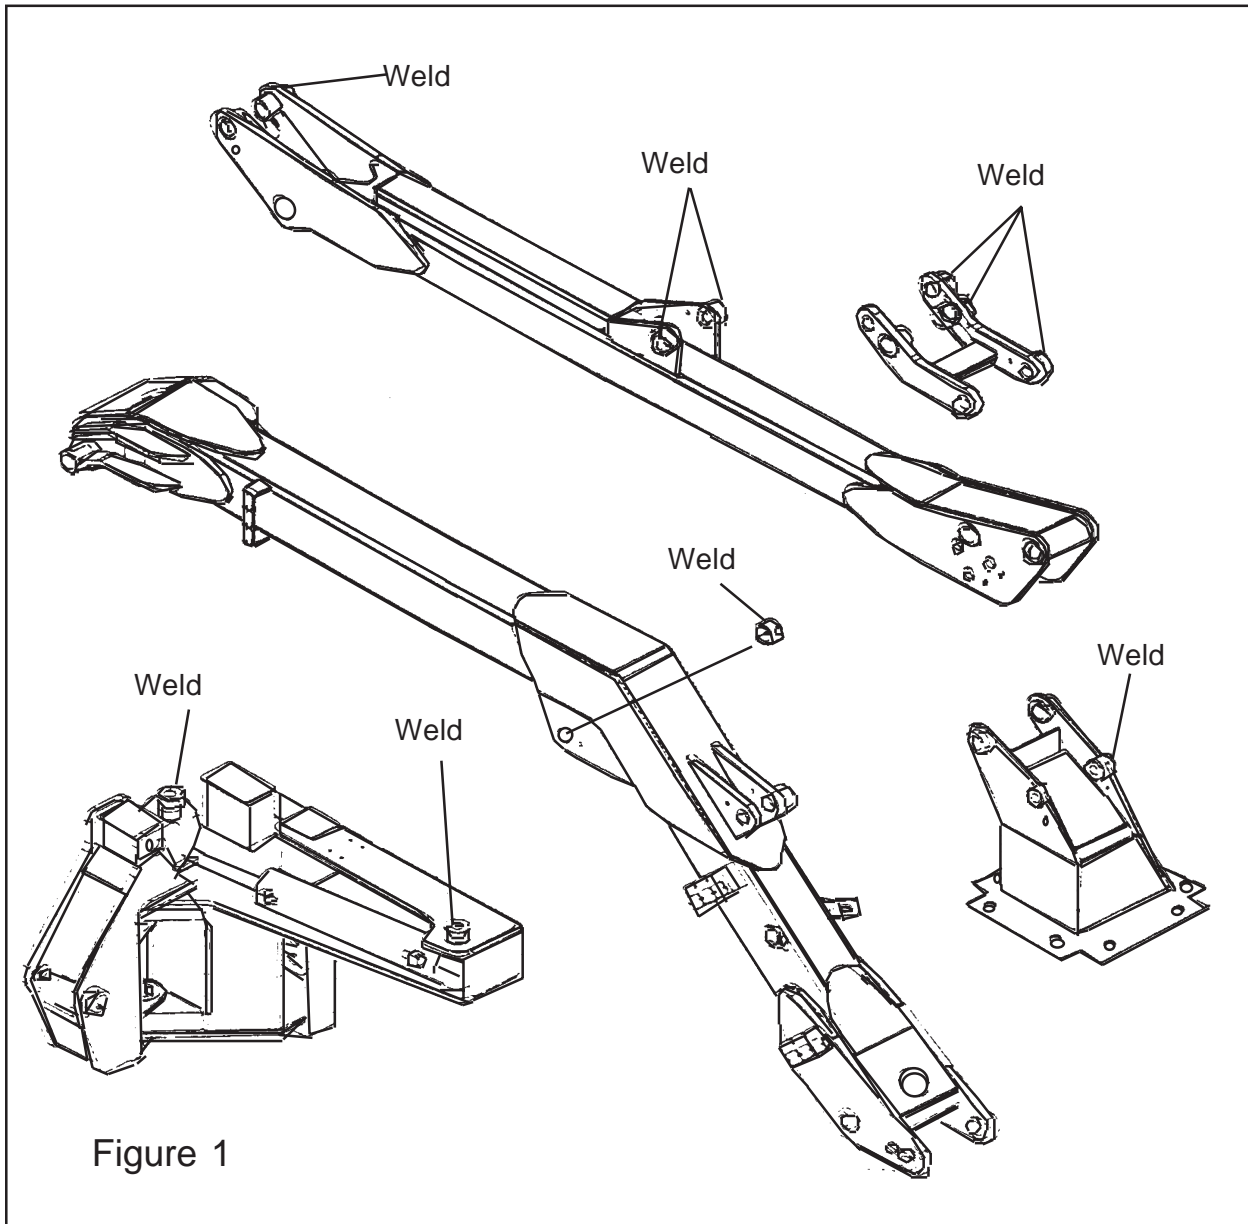
Figure 1

Boom Hinge Point Pin Upgrades. These repairs are covered in detail on Technical Information Bulletins #041797-1 and #041797-2. These Technical Information Bulletins must be consulted for detailed instructions for performing the following repairs. Also use Instruction Sheet that will be included with the Pin Kits

1. See Technical Information Bulletins #041797-1 and #041797-2 for detailed instructions on how to perform these modifications.
2. Caution must always be used when installing new bushing and when aligning the pins. Do Not try to align the pins by hitting it with a hammer, See operators manual for correct way to align pins and install bushings. It is recommended that bushings be installed with a bushing driver, these Bushing drivers are available from Alamo Industrial (See Technical Information Bulletin # 032697).

Note: Instruction Sheet is included in Kit. Check with Service Bulletin 972103 (970002A) and 971903 (970001A) as these service bulletins use some of the same parts and cover some of the same upgrades, so when ordering parts for this service bulletin check so duplicate parts (kits) are not ordered.

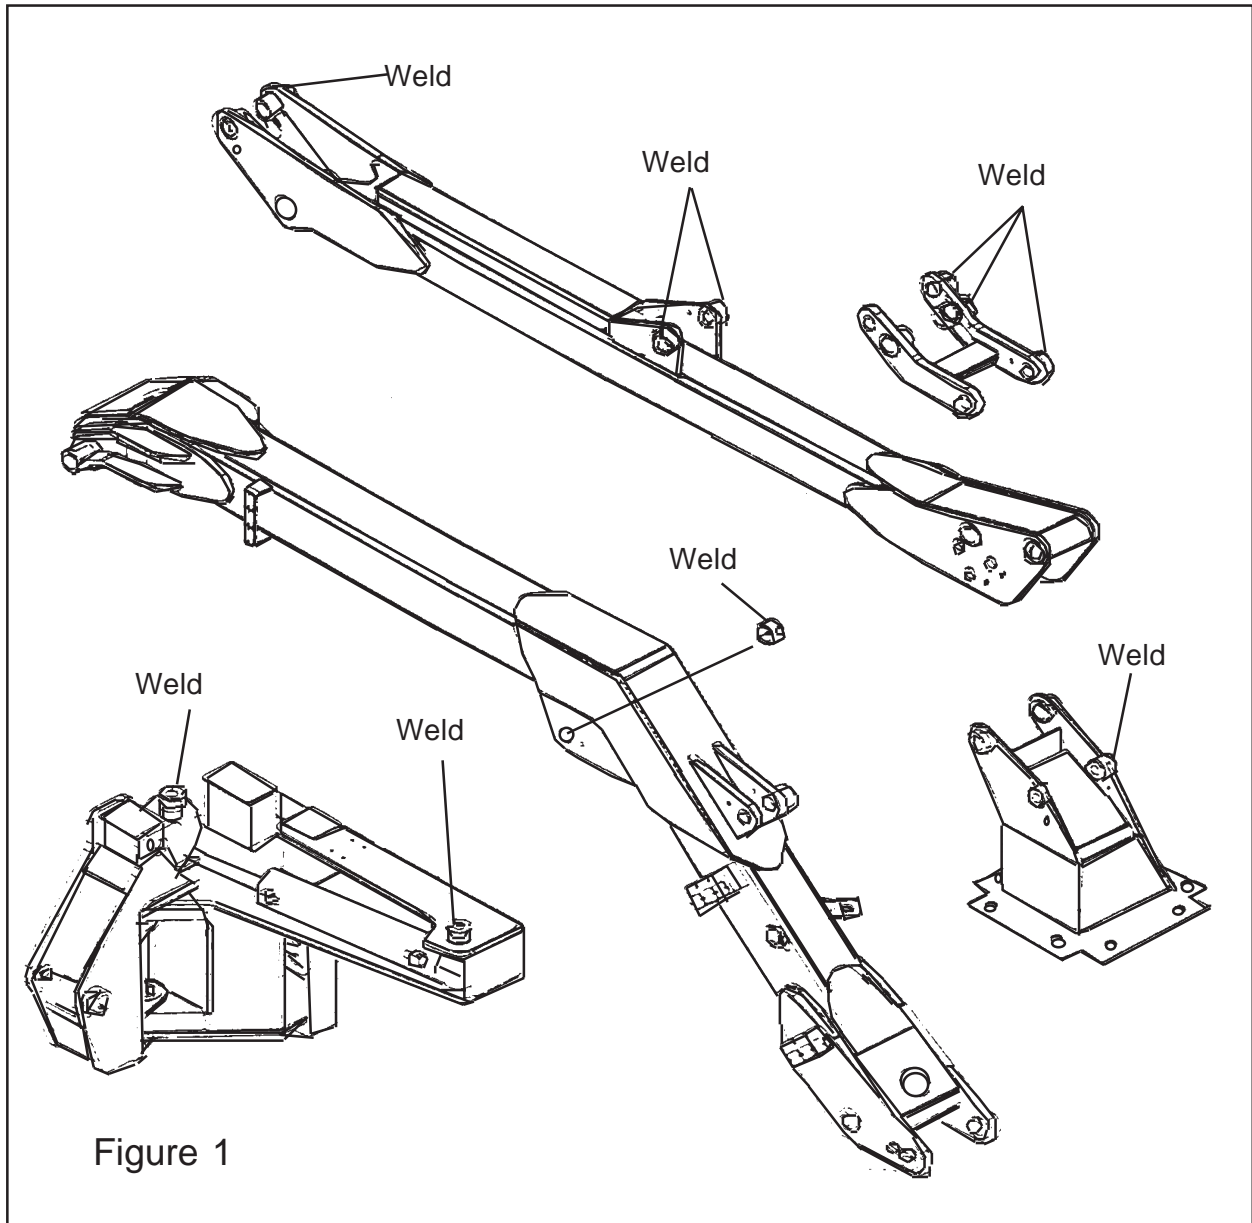
Boom Hinge Point Pin Upgrades. These repairs are covered in detail on Technical Information Bulletins # 041797-1 and # 041797-2. These Technical Information Bulletins must be consulted for detailed instructions for performing the following repairs. Also use Instruction Sheet that will be included with the Pin Kits

1. See Technical Information Bulletins # 041797-1 and # 041797-2 for detailed instructions on how to perform these modifications.
2. Caution must always be used when installing new bushing and when aligning the pins. Do Not try to align the pins by hitting it with a hammer, See operators manual for correct way to align pins and install bushings. It is recommended that bushings be installed with a bushing driver, these Bushing drivers are available from Alamo Industrial (See Technical Information Bulletin # 032697). **Use Loctite 271 brand adhesive when installing new bushings**
3. **Install the top bushing flush with the bottom side and the bottom bushing flush with the top side, this is because turning will have to go between lugs of frame.**

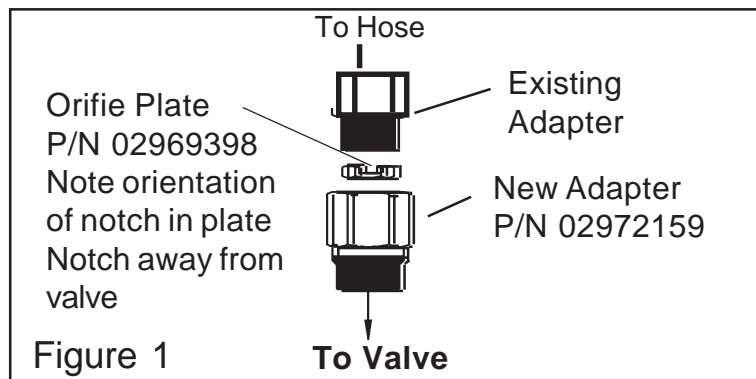
Lift and/or dipper functions drop to fast. When both functions are combined, sudden drop may occur. Install one way restrictors in the dipper cylinder rod end port and the tilt cylinder barrel end port of the control valve to prevent the sudden drop of the boom and damage to the boom and frame.

See Operators manual or Service Manual for Port locations on valve if needed.

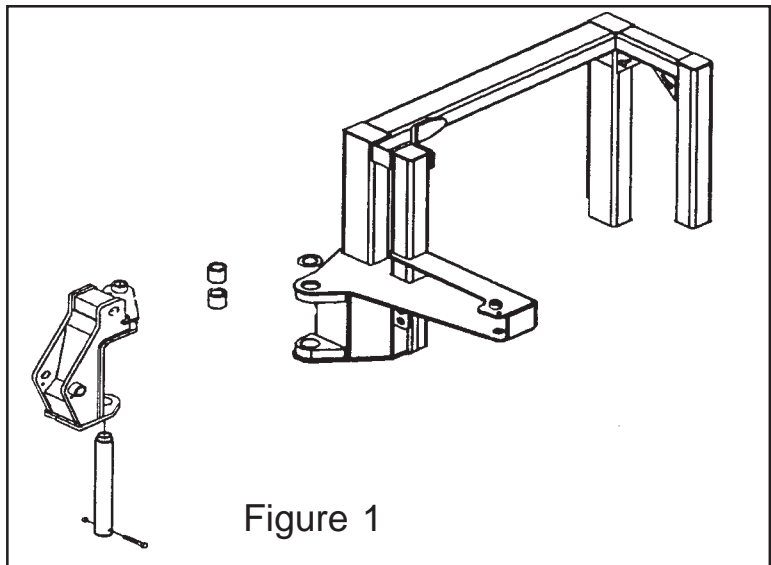
It is possible that the upper King Pin Bushing may loose retention and work down from the bore. This could result in damage to the frame, Pin and Arm.

1. Visually inspect the bushing location in the top king pin bore. The bushing should be flush with the bottom of the bore.
2. If the Bushing is in the proper place there will be no need to make this repair.
3. If the bushing appears to have moved downward in the bore, refer to the King Pin bushing replacement section in the operators manual / Service Manual for the proper procedure to support the boom while removing it. The turning arm and boom will need to be removed.

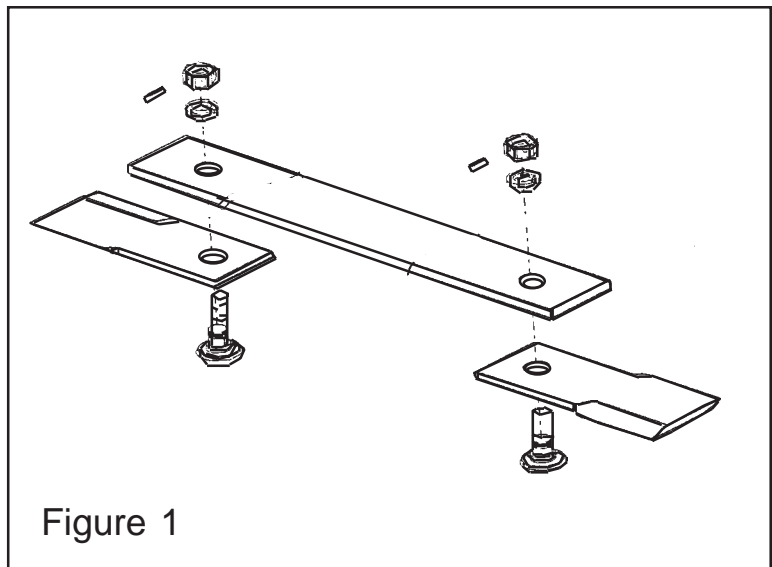
The Blade Bolt Nut Retaining Roll Pin Bore may be oversized and could allow the roll pin to become loose in the bore. The loose roll pin could therefore allow the blade bolt Nut to loose torque.

1. Visually inspect and check the fit of the roll pin. If it is loose or has come loose replace the Blade Bolt, Blade Bolt Nut and Roll Pin on the above listed serial numbered units.
2. Torque the Blade Bolt to 600 ft. lbs. before installing the new Roll Pin.

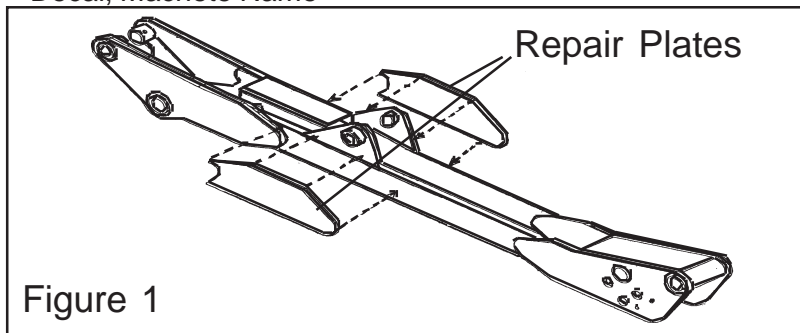
Loads and the resulting stress incurred during heavy to abusive operation of the Machete Boom may allow for fracture of the outer (Dipper) Boom at the welds which attach the base end mount of the Head Tilt Cylinder.

**Parts Required:** (MB21 & MB24 use different Plates & use 2 Plates per repair)

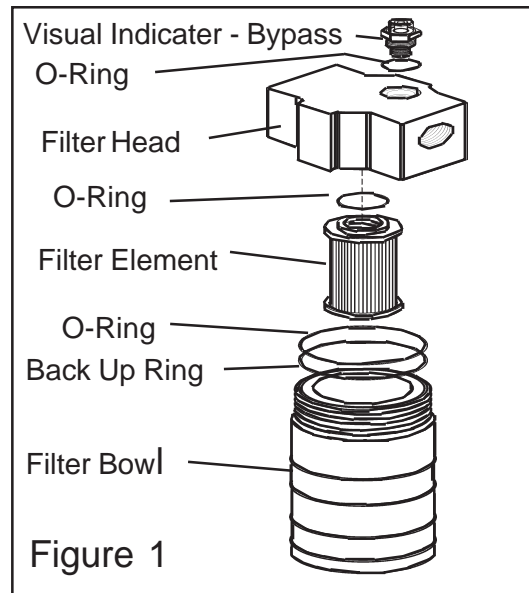
A new filter kit P/N 02976069 has been developed and must be installed to help prevent some contamination failures of the control valve system due to normal gear and brake wear within the tractor hydraulic system. This new filter system has an indicator that will show when the filter is plugged, see Technical Information Bulletin 032200 for more detail.

Note: The new filter will mount on the Inlet (pressure) side of the control valve which is mounted on the right hand frame rail. The hardware (Elbows) and instruction sheet are included. Read these prior to beginning any repairs or modifications. Always refer to operators manual for safe procedures when working around equipment.
